STORM EVENT OF OCTOBER 8-10, 1991

December 1991

**South Florida Water Management District
West Palm Beach, FL**

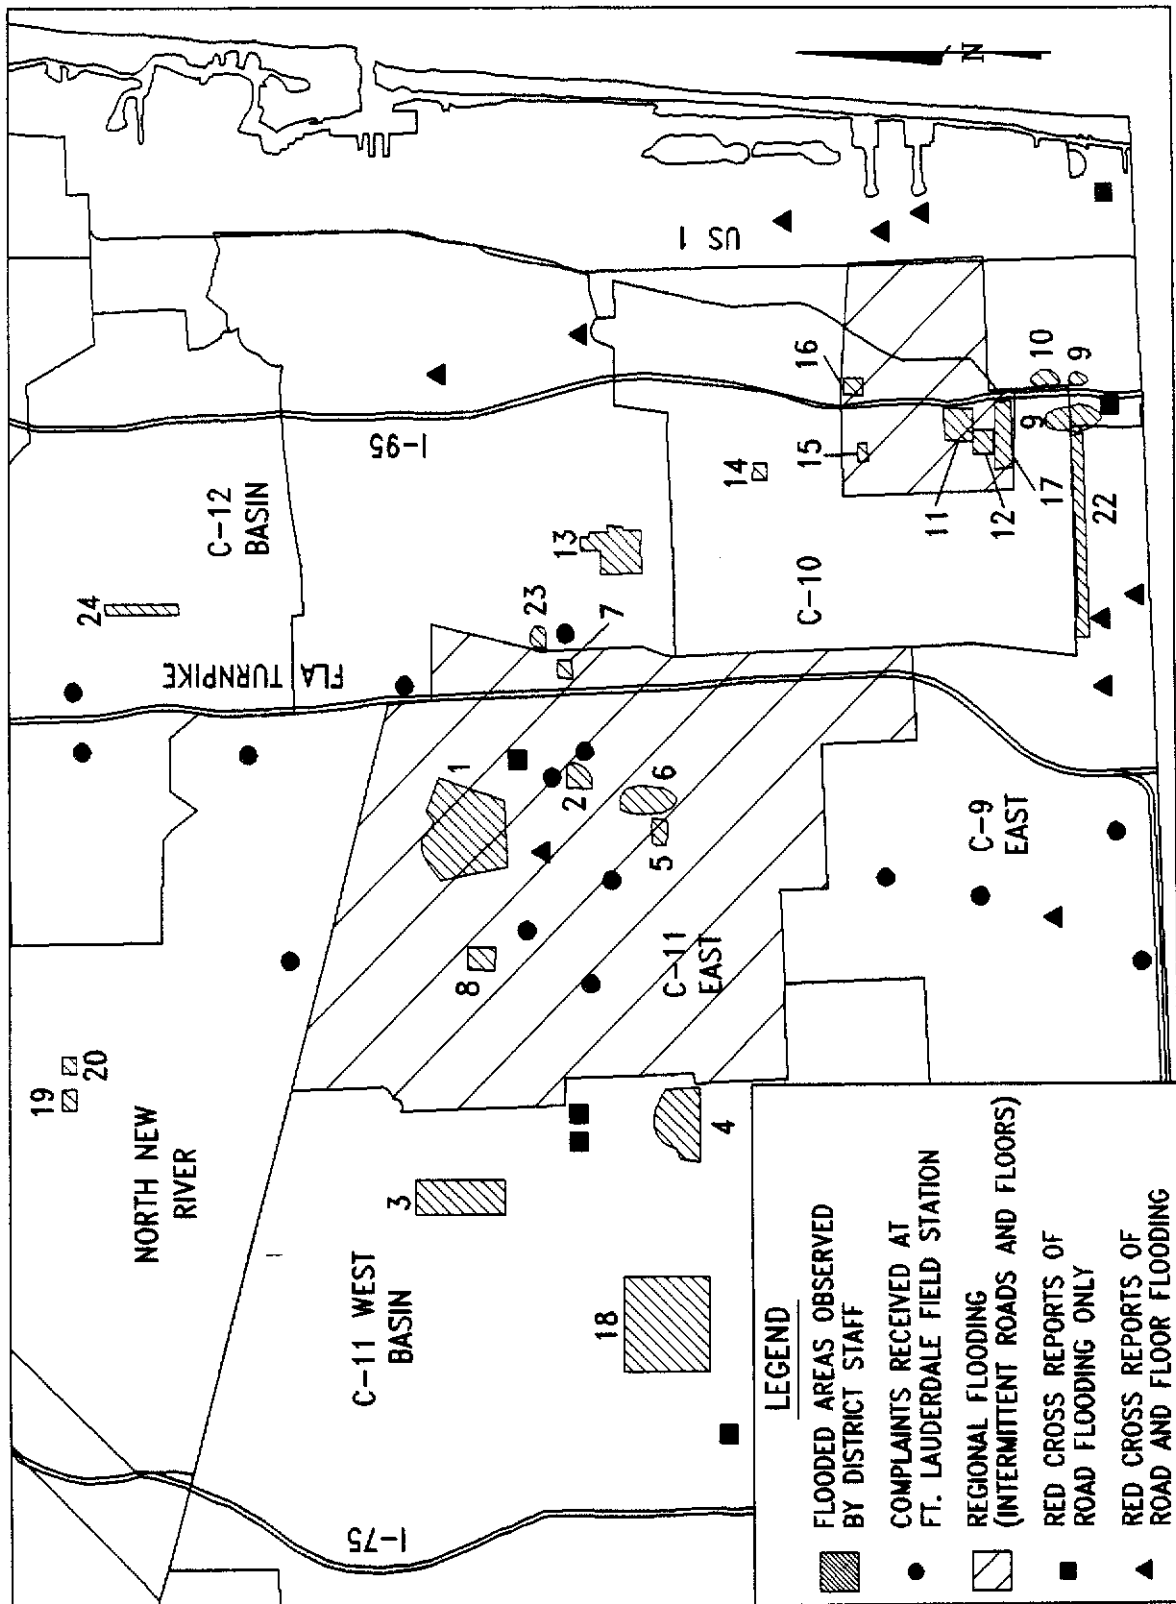
Figure C-3. Areas of Observed and Reported Flooding in South East Broward County

- r. Sunshine Acres: High water caused drainfield problems [18].
- s. Sunset Strip from NW 91 Avenue to NW 96 Avenue: Street and yard flooded to 6 inches [19].
- t. Pine Island Rd./Sunset Strip intersection: Flooded to 20 inches, street closed [20].
- u. Godfrey Road at Wiles Road: Streets and paddocks flooded to 10 inches [21].
- v. Miramar Parkway east of 441: Street closed due to flooding, depth unknown [22].
- w. Broward Resource Recovery Plant: Water inside of the ash landfill breached the surrounding dike. There was no discharge of water offsite, and the breach was repaired within one day. FDER kept on top of this [23].
- x. NW 39 Avenue from 4 Court to Seventh Street: Streets and yards flooded to 12 inches. Homes flooded to 4 inches [24].
